McGrath Pond/Salmon Lake Watershed Nonpoint Source Pollution Survey

McGrath Pond/Salmon Lake Association
Maine Department of Environmental Protection
January 1999

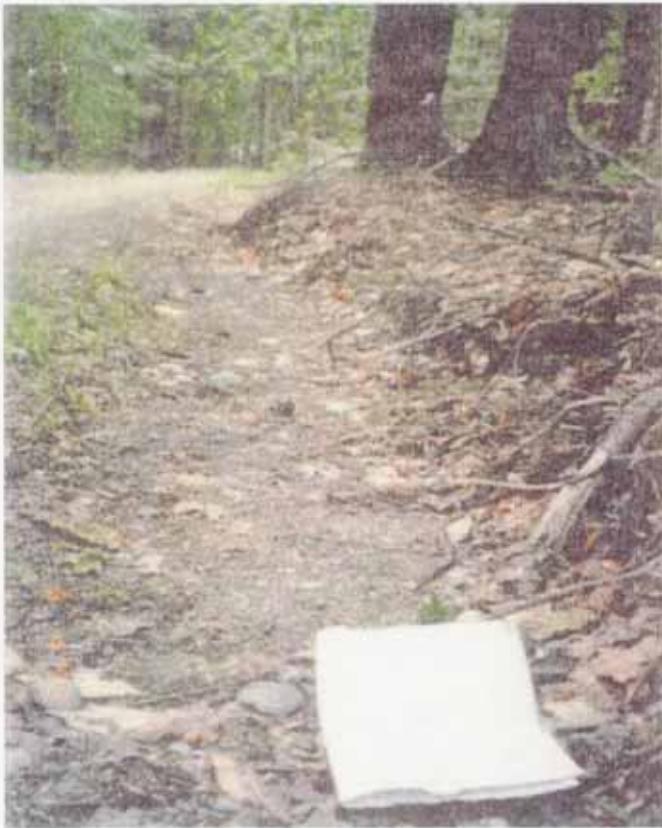
Photo 1-lack of ditch

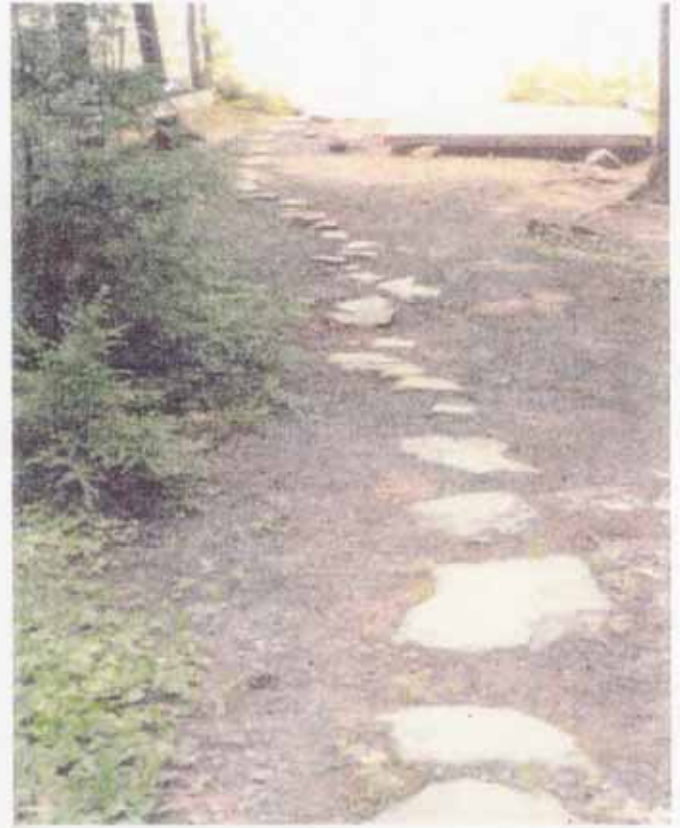
Photo 2- residential site

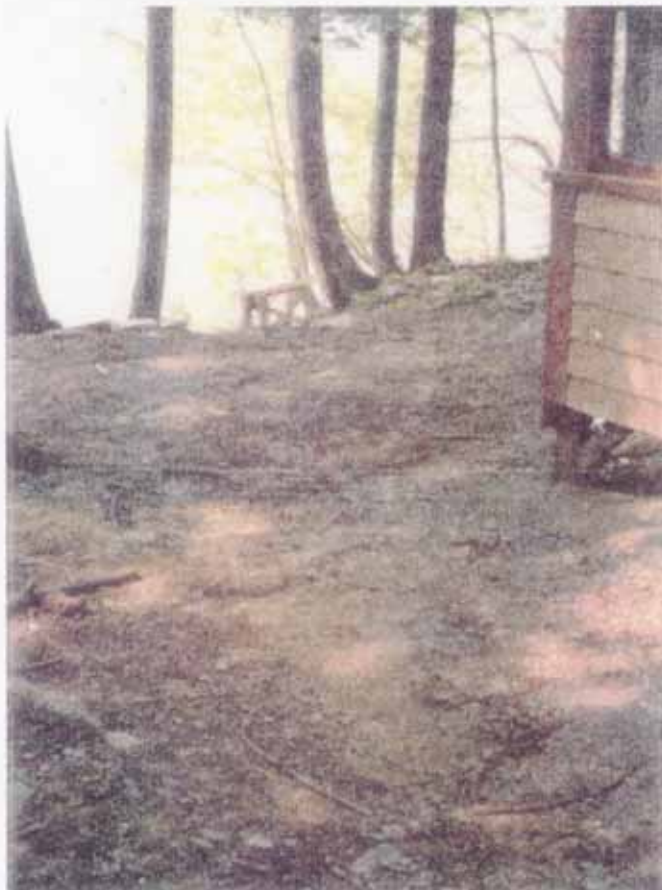
Photo 3- residential site

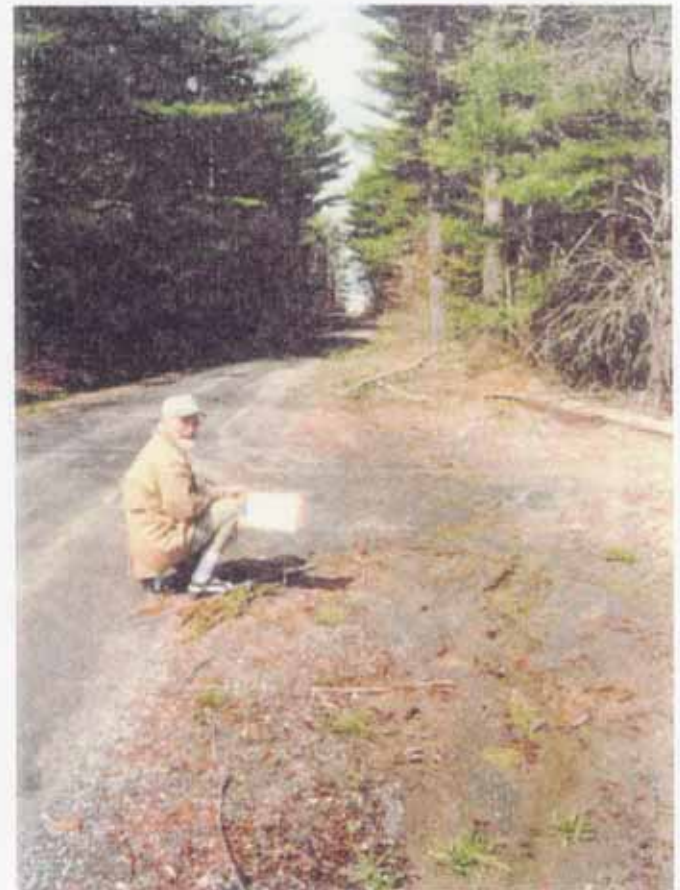
Photo 4- road surface erosion

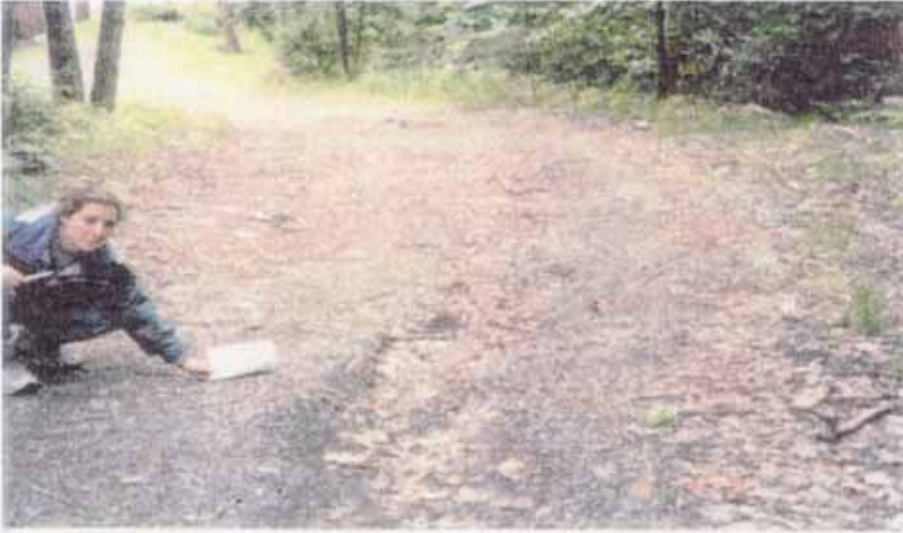
Photo 5 - eroded dr ive

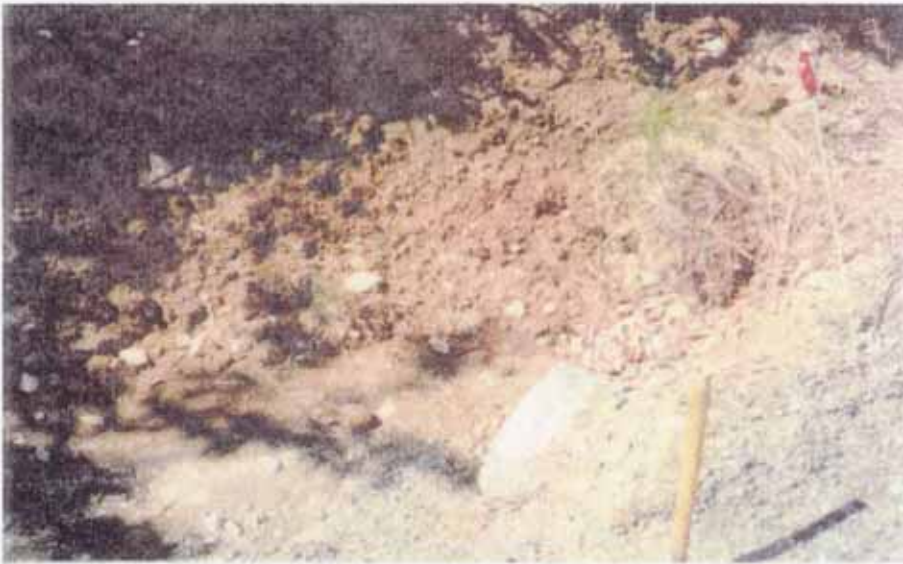
Photo 6- unstable culvert

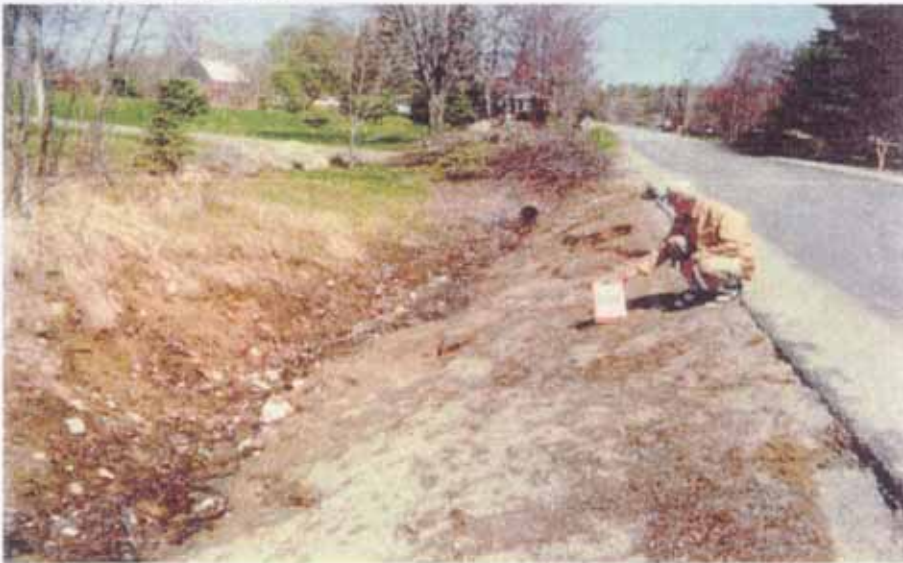
Photo 7- road ditch
